Comprehensive Reserve Fund Study

for
Carleton Condominium Corporation No. 276

October 5, 2017

Project L2690

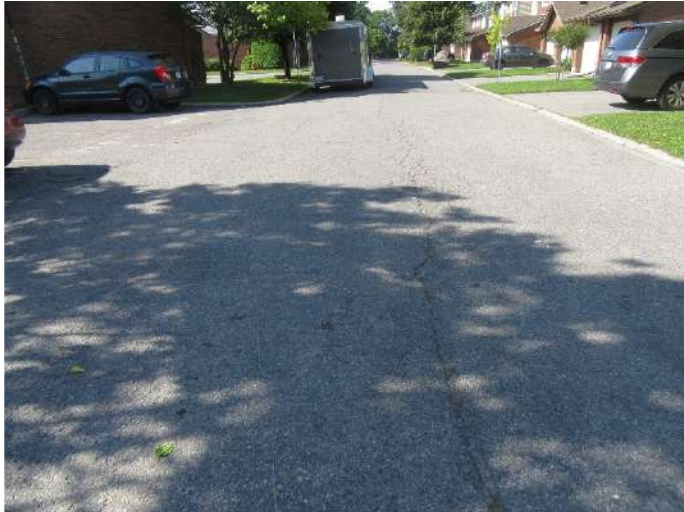
The asphalt paved roadways and visitor parking is in overall fair condition. As such, we budgeted \$145,000 to reconstruct the pavement in 2020. This work generally involves excavating the existing pavement, adding new granular base as required, compacting and grading the base, and installing new pavement. The reconstructed pavement should provide 15 years of reliable service, after which time an overlay will likely be required. Accordingly, we budgeted \$70,000 to overlay the pavement in 2035.

Photo B.3 – Showing longitudinal cracking through roadway asphalt pavement.

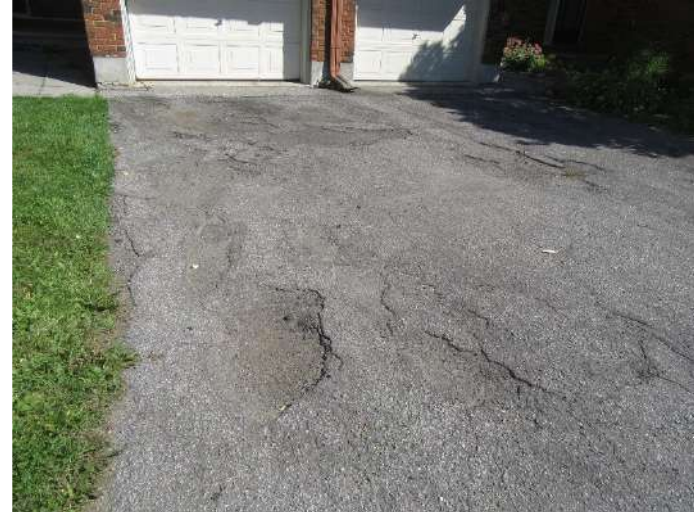
The paved driveways vary from very good to poor condition. Approximately five driveways each year have been replaced over the last few years, and these driveways are in good condition. However, the remaining driveways are in fair condition as they display deterioration, cracking and settlement. Therefore, to continue with the Board's approach, we budgeted \$5,000 in 2018 and 2019, to replace around five driveways each year. In 2020, we budgeted \$40,000 to replace all remaining driveways in conjunction with the asphalt roadway reconstruction work. The new driveways should provide about 20 years of reliable service when reconstruction will again be required. Therefore, we budgeted \$70,000 to replace all driveways a second time in 2040.

Photo B.4 – Showing depressions and deterioration of the asphalt pavement at a driveway.

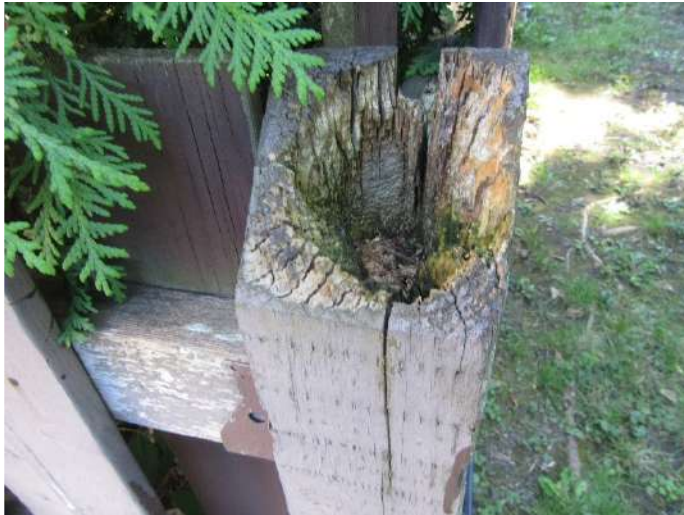
The stained wood fences are in fair condition, since they exhibit deteriorated boards and loose and/or leaning posts. In addition, the fences are not of a sturdy design and significant post bottom deterioration was observed due to grass trimmers and wood decay. Therefore, we budgeted for the fences to be replaced in 2021 and 2022, at a total cost of \$90,000. The new fences should provide around 20 years of service before replacement will again be required, so we budgeted another \$90,000 to replace the fences a second time in 2041 and 2042.

Photo B.5 – Deteriorated post at a privacy fence.

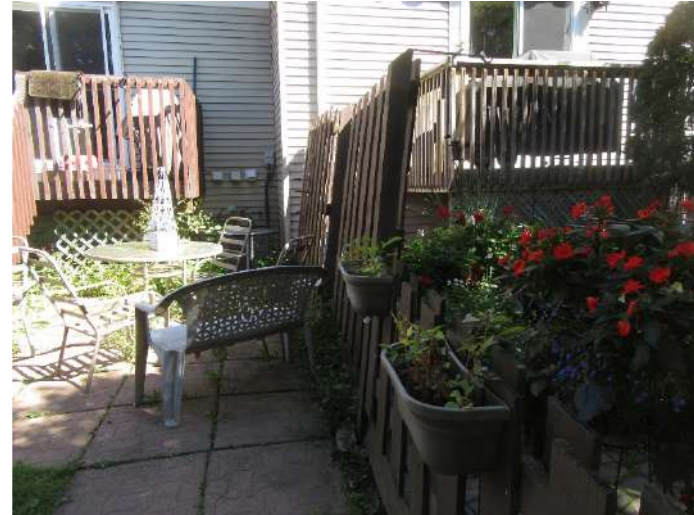
Photo B.6 – Showing fence posts that are leaning.

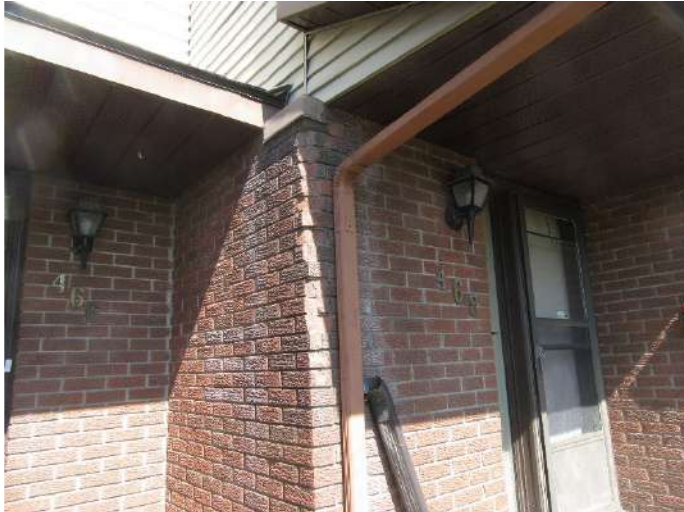
Overall, the brick masonry veneer is in satisfactory condition, and only minor deteriorated mortar joints and isolated spalled bricks were observed in localized areas. Brick masonry repairs should be conducted, as required, using funds from the contingencies allowance. With minor repair and maintenance work performed on the brick masonry, no significant masonry expenditures are anticipated in the 30-year scope of the Study.

Photo B.7 – Showing spalled bricks.

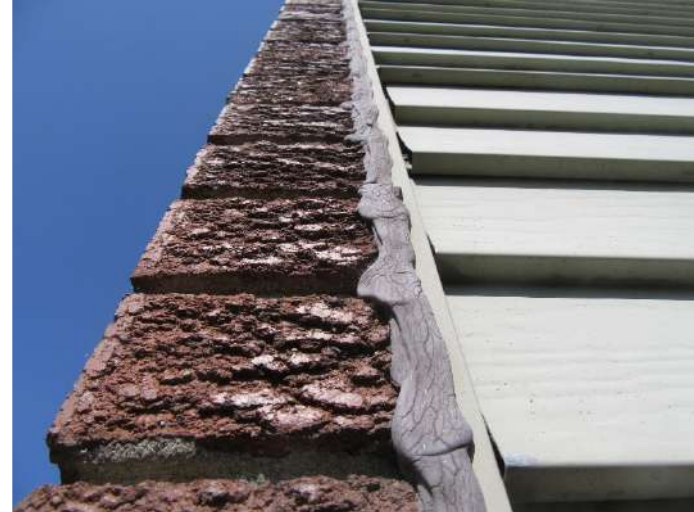
Exterior caulking ranges from fair to satisfactory condition. Caulking around the perimeter of windows and patio doors was noted to be in satisfactory to good condition, while the caulking at cladding joints is in fair condition. Therefore, during the next painting program, as required caulking replacement should be conducted using funds from the general contingencies allowance. Once caulking touch-ups are conducted, only a limited amount of caulking will require renewal, as most of the caulking will be replaced with the siding and window replacement work. Therefore, no funds for replacement of caulking are budgeted in the spreadsheet. Localized calking repairs should be carried out using funds from the general contingencies allowance.

Photo B.8 – Showing deteriorated caulking at cladding junction.
